**SEASONAL MONITORING PROGRAM
DISMANTLE REPORT
SITE 041024, FLAGSTAFF, ARIZONA**

March 1999

TO: Mr. Aramis Lopez, Jr. FILE: 800.17.1
Long-Term Pavement Performance Division
FROM: Srikanth S. Holikatti and Douglas J. Frith (DSF)
DATE: March 16, 1999
SUBJECT: Suspension of SMP Site Monitoring Activities, Site 041024

SECTION 041024
Flagstaff, AZ

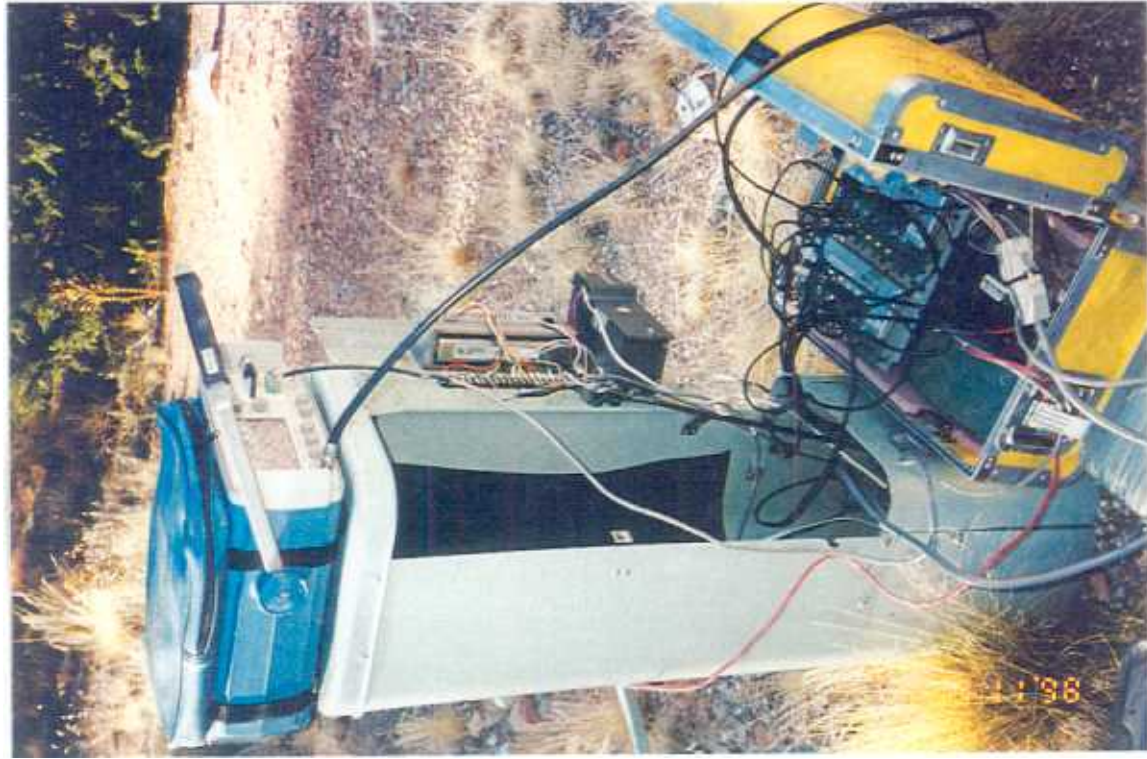
Photo 1. Last set of data collection in progress.

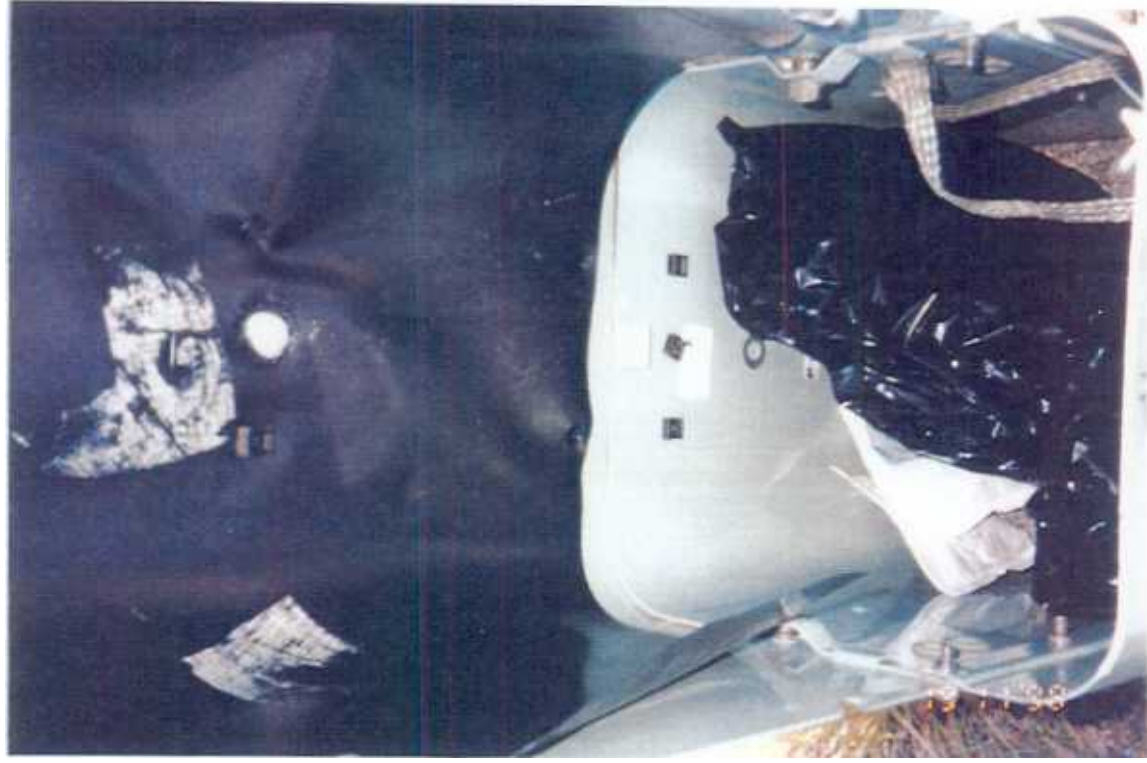
Photo 2. Tied, taped sensor cable ends in the instrumentation box.

- All TDR probes, thermistor temperature sensor unit cables and wiring were disconnected from the CR10 datalogger. These were carefully checked and labeled. Labels on each cable were scotch taped to ensure they would remain in place.

- A coat of electronics grade anti-corrosive compound was applied to all the cables and wiring connections to protect against corrosion of contact points. The cables were then put in a heavy duty plastic bag and were taped to keep out the elements and were then secured inside the equipment cabinet.

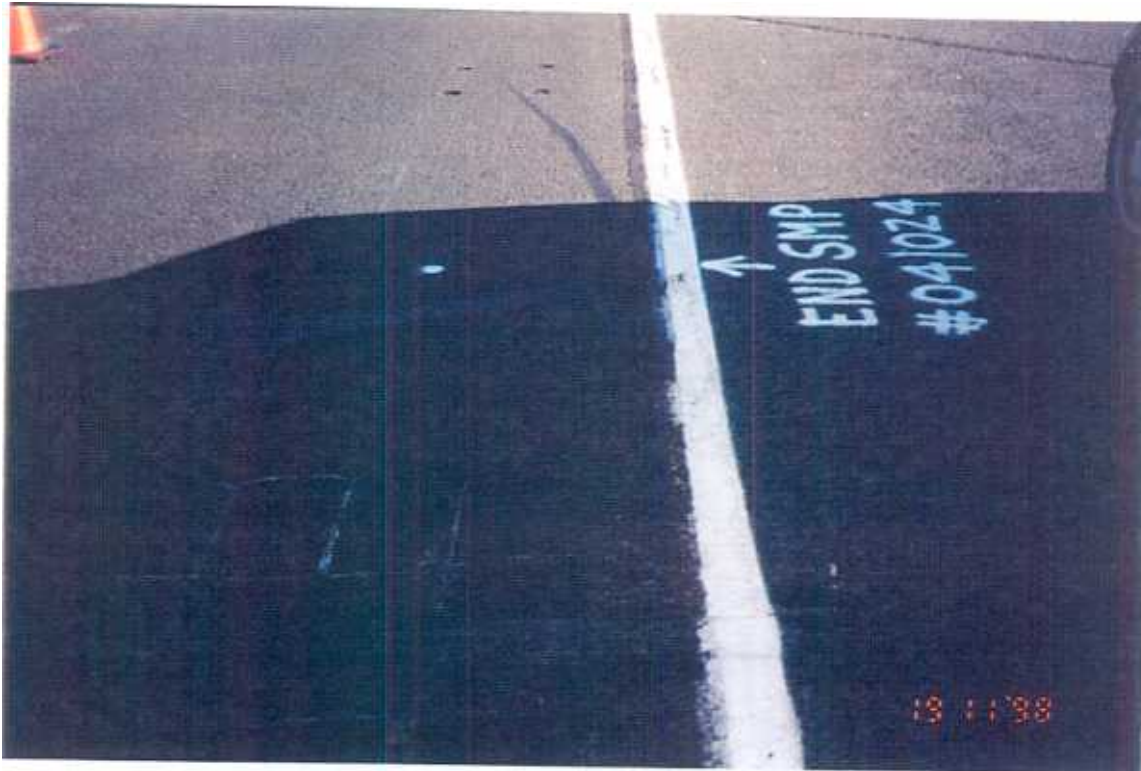
- The instrumentation hole and access trench were both closely inspected and the joints were sealed with silicone sealant wherever necessary. No further patching was required.

Photo 3. Instrumentation hole and access trench.

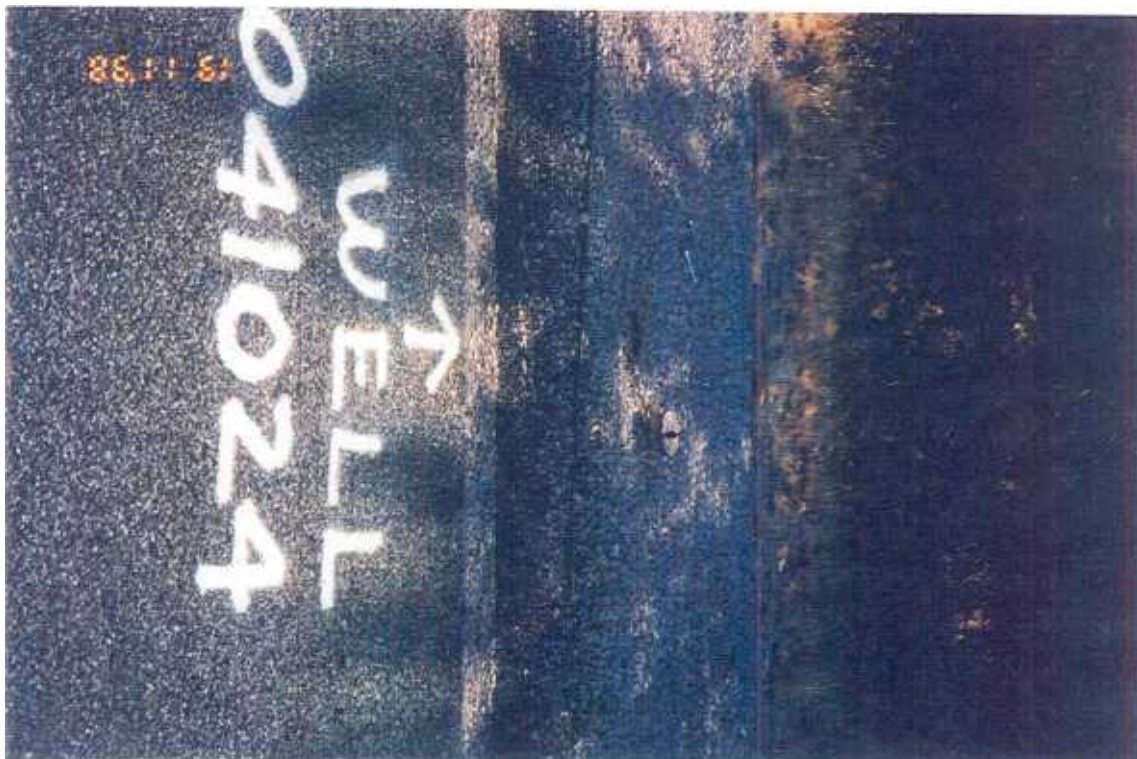
Photo 4. Observation well.

- The observation well and cap threads were thoroughly cleaned and lubricated (greased) before the well was sealed.
- The air temperature probe and rain gauge were disconnected from the steel pole and the pole was removed from the bottom joint. The pole stub, embedded in the ground, was cleaned and lubricated before capping.
